AFWAL-TR-88-3008

**AUTOMATED EARLY
FATIGUE DAMAGE
SENSING SYSTEM**

Grumman Aerospace Corporation
Bethpage NY 11714-3582

May 1988

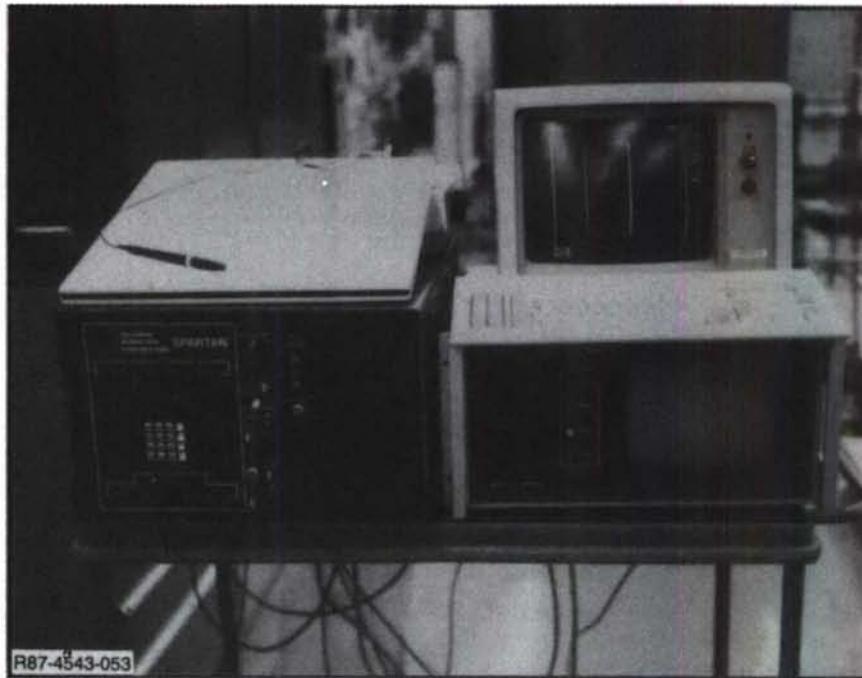
Fig. 35 Fully Configured System Showing Digitizer and Data Acquisition, Computer Display, and Keyboard

A series of final demonstration tests were conducted using the fully configured system (see Fig. 35 and 36). The decision to conduct dedicated testing on specially designed test specimens was based on the non-availability of ongoing structural tests and the need for precise correlations. The dedicated test permitted cycle interruptions immediately following first event detection, which enabled initial crack size measurements. The dedicated test also per-
